# K K Enviro Tech Pvt Ltd

## Case Study

### Clogging and Chocking Protection of Water Intake

Owner: **Hindalco Industries Ltd.**

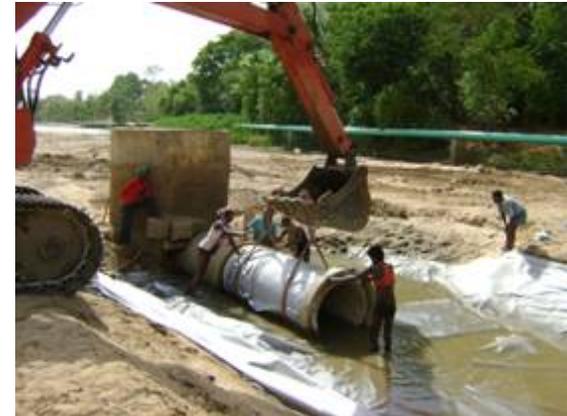
Installing geotextile wrapped around pipes

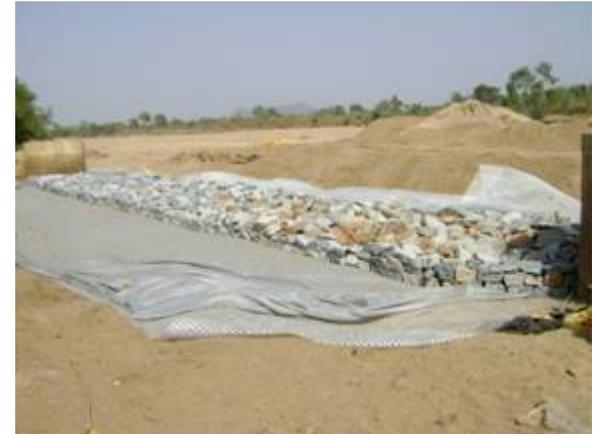
**Boulders for gabion mattress**

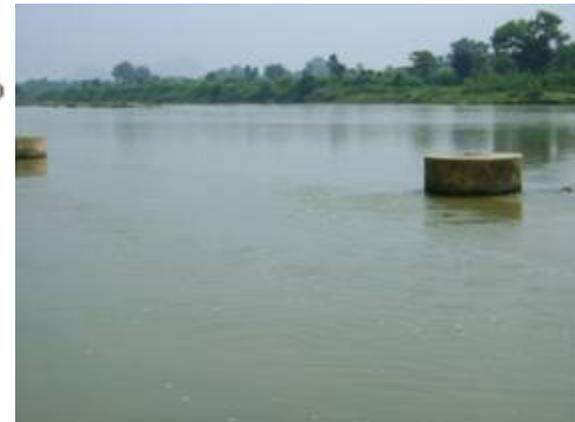
**after 5 months**
