Case Study

Erosion Control and Seepage Control of embankment of closed red Mud Pond

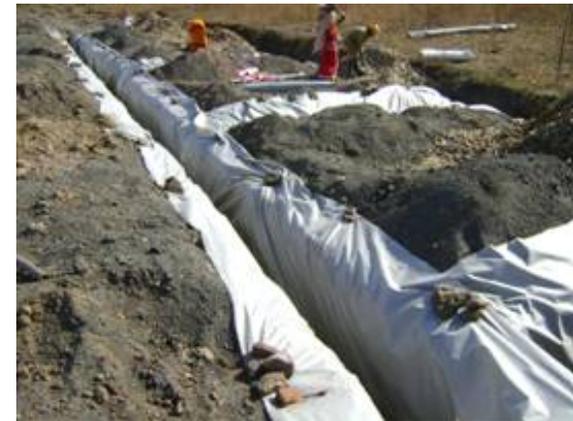
Fibertex F-25 NW Geotextile for Trench drains

3. Trenches were cut on slopes and completed with laying of Viadrain and perforated pipes. The soil from these trenches was used as backfill.
4. A trench drain was made parallel to the embankment 1.5 m away from the edge. The trench was 1 m deep and 0.5 m wide. Fibertex F-25 was laid filled with stone metal.

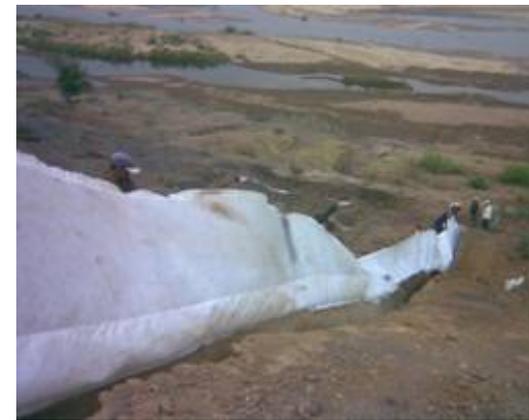
Installation of Viadrain in slope trench

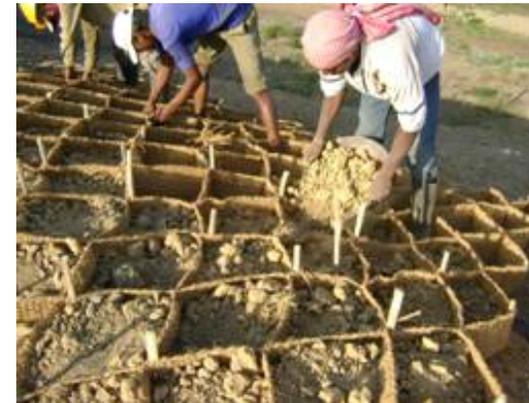
Installation of Coir Geocells and soil

5. In the bottom trench Viadrain was placed and the trench was filled with excavated soil.
6. coir geocell was placed over the whole sloped area. The geocell layer was extended 1.5 m over the shoulder of the slope.

7. geocell was half filled with top soil and seeds.

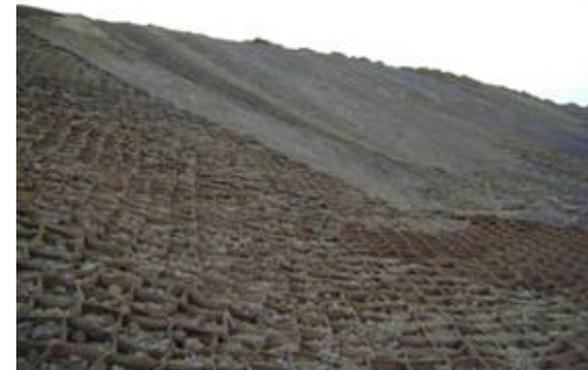
Barren slope after drainage works

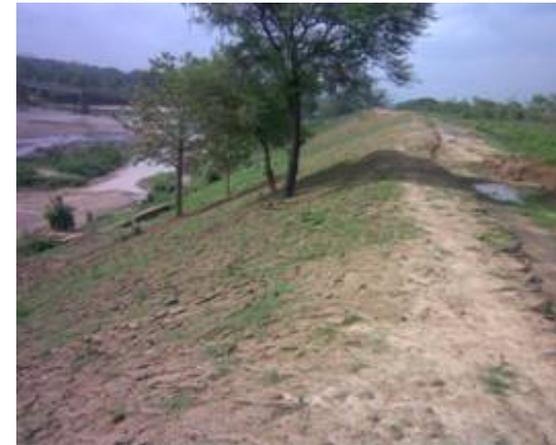
Vegetation growing after 40days

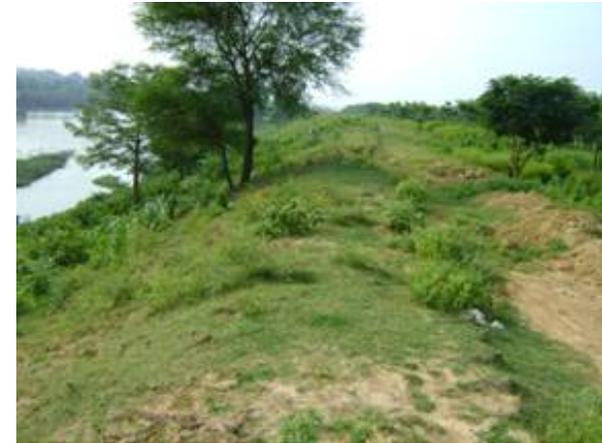
Vegetation growing after 100 days

After the first monsoon it has been found that the area has become totally green with no visible signs of erosion. There has been no seepage from the embankment. The water is clear and contains pollutants within specified limits.
