Case Study

Closure and capping of old Landfill at Gorai, Mumbai

Owner: **Brihan Mumbai Municipal Corporation**
 Consultant: **ILFS Ecosmart Ltd**
 Contractor: United Phorphorus Ltd and Van Der Viel, Netherlands
 Land Area: 19 hectares
 Location: Mumbai. Next to Gorai Creek
 Rainfall: >300 cm in 4 months
 Waste dumping Started: 1972
 Peak waste received: 1200 tpd
 Height of waste at the time of closure: 60 to 80 m.
 Cost: 54 Crore
 Recovery of Investment Carbon Credits

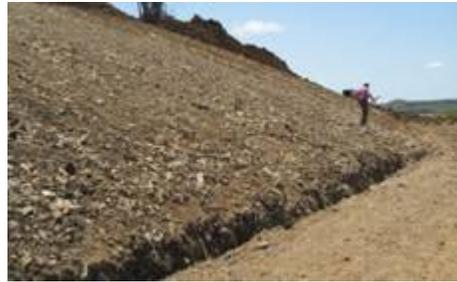
Grading of waste

1. Sheet piles were inserted 15m deep all around the waste.
2. The waste was graded to a slope angle of 30 degree with benching every 20 metres..
3. 30 cm thick regularization layer of soil was placed over the waste.
4. Nonwoven geotextile made of polypropylene was installed over the soil regularization layer. Joints were stitched.
5. 2.0 mm thick HDPE geomembrane was installed. Joints were heat welded and checked for leaks.
6. Intermas Drainage geocomposite was placed to allow rain water to drain and prevent the top soil from becoming saturated under heavy monsoons in Mumbai.
7. A 30 cm of top soil which could support growth of vegetation was laid.
8. In some areas, Coir geotextile was laid to control erosion till vegetation could grow dense root. In some areas grass sods were planted.

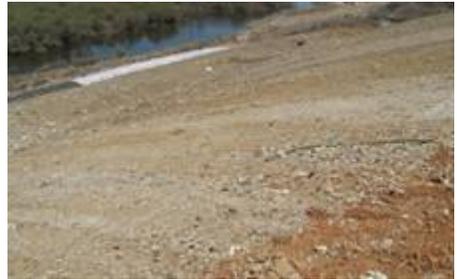
Soil Regularization layer

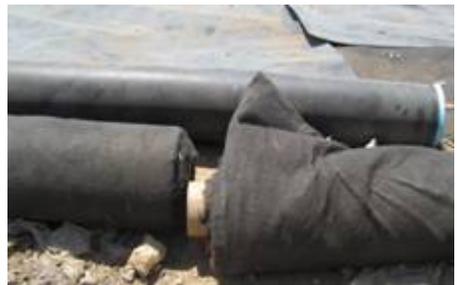
Geomembrane and Geotextile

Steel Sheet Piles
 400 gsm PP Nonwoven Geotextile as protection to impermeable geomembrane

2.0 mm thick HDPE geomembrane.
Intermas Geocomposite GMG512 for drainage of rain water

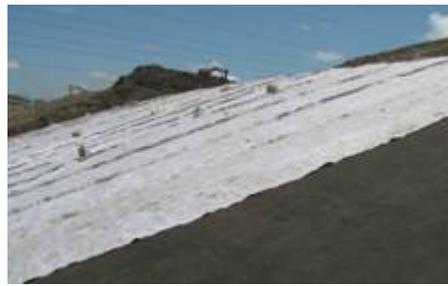
Drainage Geocomposite

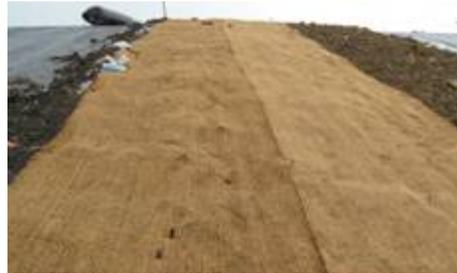
Top Soil and Coir Erosion control Blanket

Coir erosion control blanket to hold top soil on moderately steep slope

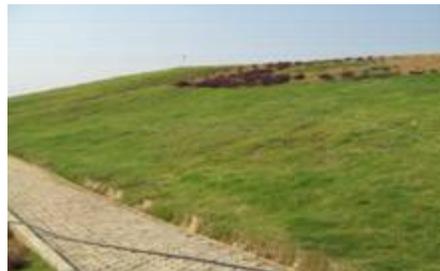
Final Result

Watering of slope was not required as rainy season began soon after installation. Watering of slope was not required as rainy season began soon after installation. However, watering was required during the summer season to keep the grass green.
