CASE STUDY – Seepage control with Geomembrane

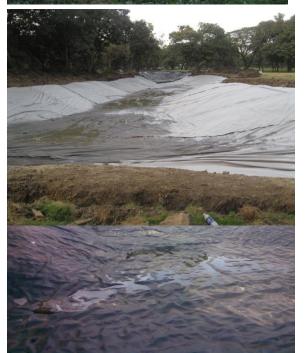
Fibertex F-40 PP Nonwoven needle punched Geotextile was placed on the soil to provide protection to the geomembrane and decrease chances of

puncturing of the geomembrane.

1 mm thick HDPE Geomembrane was laid over the geotextile and welded to form a water tight structure. The geotextile and geomembrane were anchored in trenches of size 60 cm X 60 cm
